CASE STUDY:

Hyatt Regency Grand Cypress Hotel

Orlando, Florida

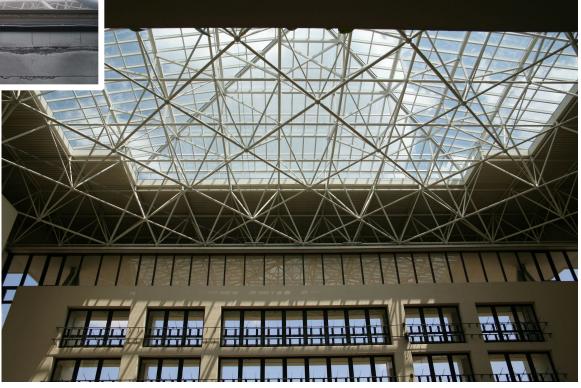
The skylight sits above the main atrium and had significant leaking problems for many years. The skylight consisted of acrylic bubbles on a gutter system which was supported by a steel space frame. In heavy wind storms, some of the acrylic bubbles had even blown off the building. The owner wanted to replace the system with a hurricane compliant, energy efficient skylight that would not leak. Super Sky provided a custom glass skylight solution that solved all of the existing problems. This skylight removal and replacement was able to be accomplished with minimal disruption of the daily operation of the atrium space.
